Report

Incident on **2 June 2010**

Bordeaux FIR, OLRAK Point

between the **A318** registered **F-GUGJ** operated by **Air France**
and the **PC 12** registered **EC-ISH**

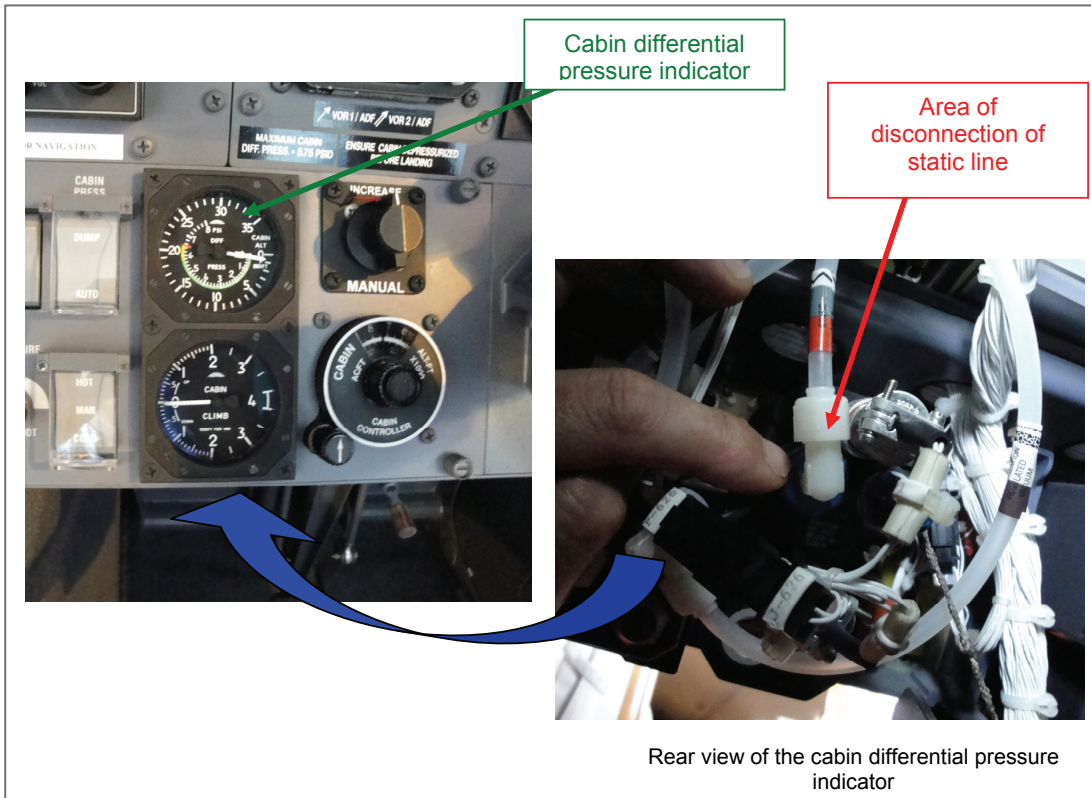
Figure 6

On the PC 12, before performing this test, it is necessary to disconnect the N°1 static line at the level of the cabin differential pressure indicator in order to protect it from the high pressures used during the test. This disconnection is done by unscrewing the connector located on the rear panel of the differential pressure indicator (see figure 6). At the end of the test, the connector is screwed back on. This manipulation is made tricky due to the limited space and the presence of an electrical plug near the pipes.

At the end of this test, the static circuit is subjected to an impermeability test. In this case, this test did not reveal a leak.
